Fire Programmer's Reference Manual

For Fire 2.1

Release Date: July 30, 2007

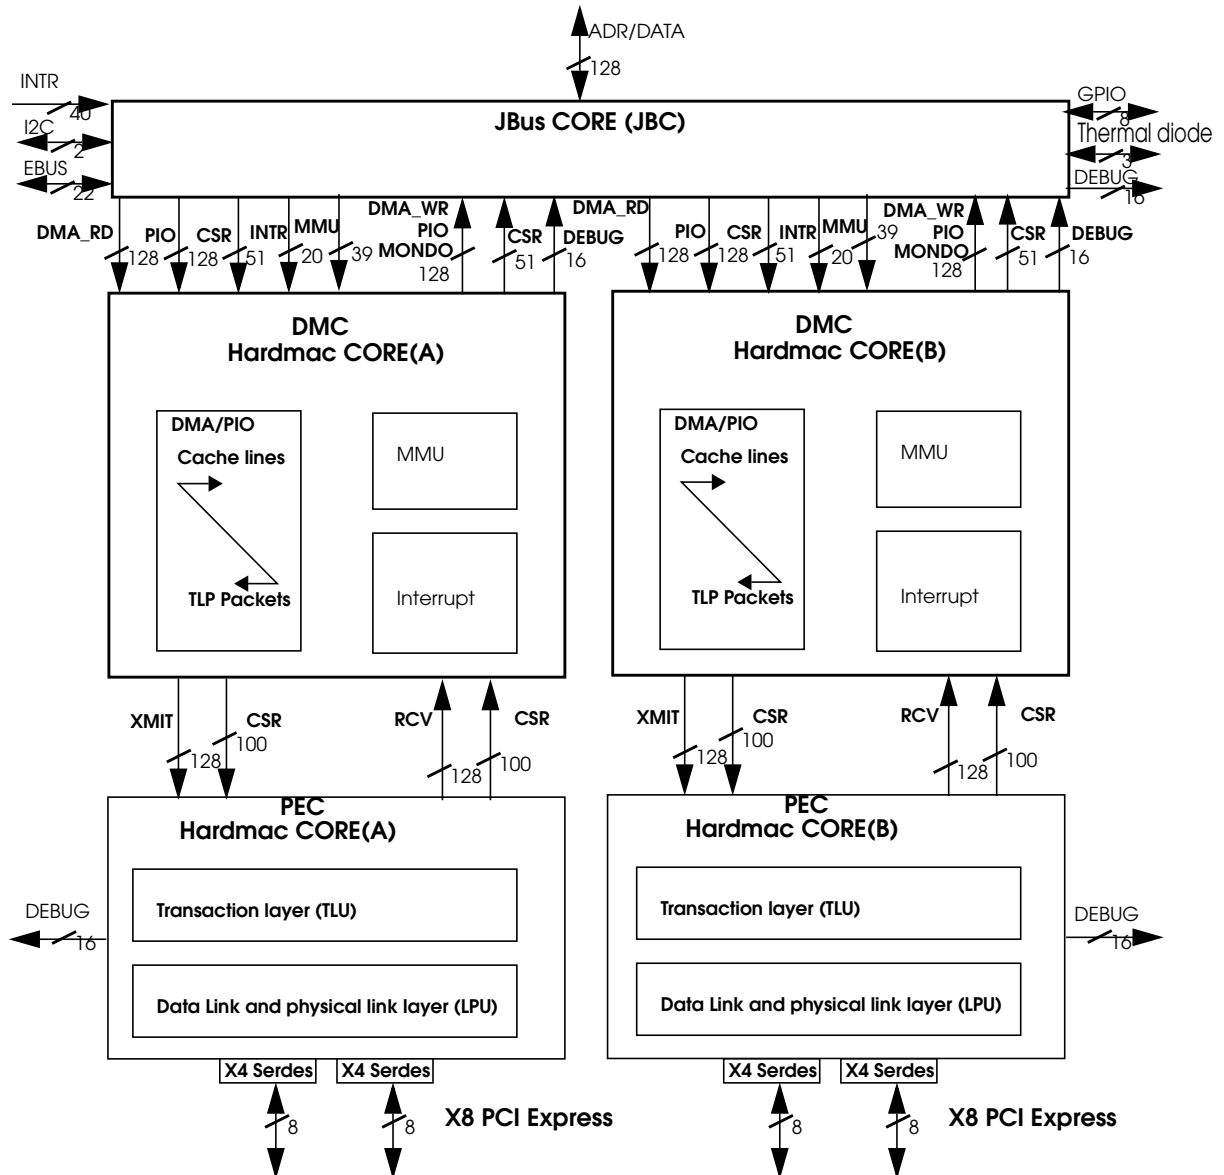
Figure 1-1 Fire Block Diagram

1.1.3 Fire Block Diagram

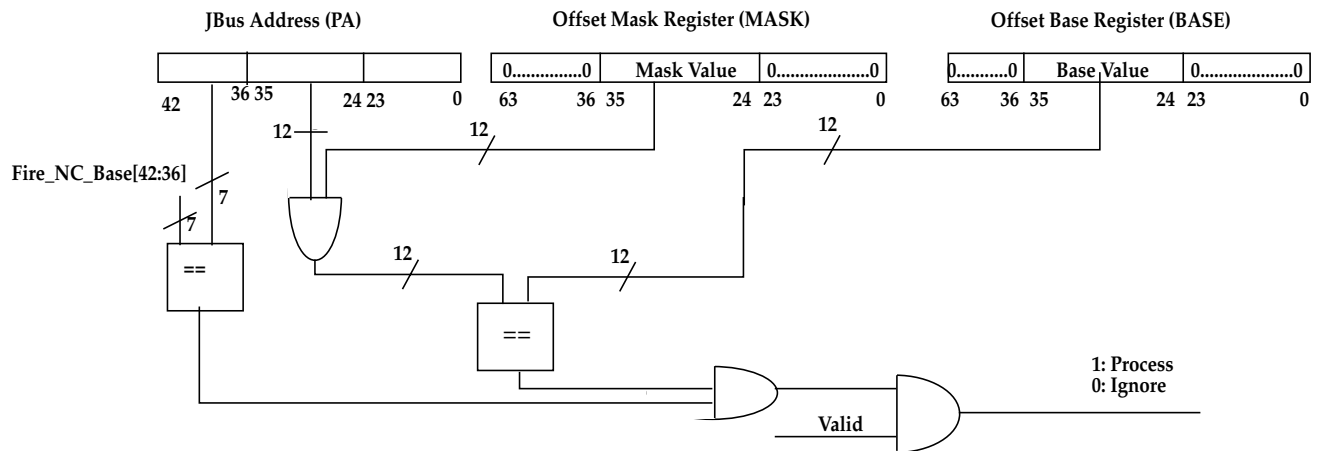
Figure 1-2 Address Filtering in Fire

The address filtering is performed as described by the figure below:

$$\text{Process} = (\text{PA}[42:36] == \text{Fire_NC_Base}[42:36]) \& ((\text{PA}[35:24] \& \text{MASK}) == (\text{BASE})) \& \text{Valid}$$

Fire first checks PA bits [42:36] ([42:41] == 11, [40:36] == AgentID[*]) to see if it should respond to the JBus Address, where * = one of the 2 possible Agent ID's for the given slot which Fire is in (1C or 1D for slot 4 or 1E and 1F for slot 5). If the address is found to be within its memory range, bits [35:24] are masked with (bitwise AND) Offset Mask register bits [35:24] and compared against the Offset Base register bits[35:24].

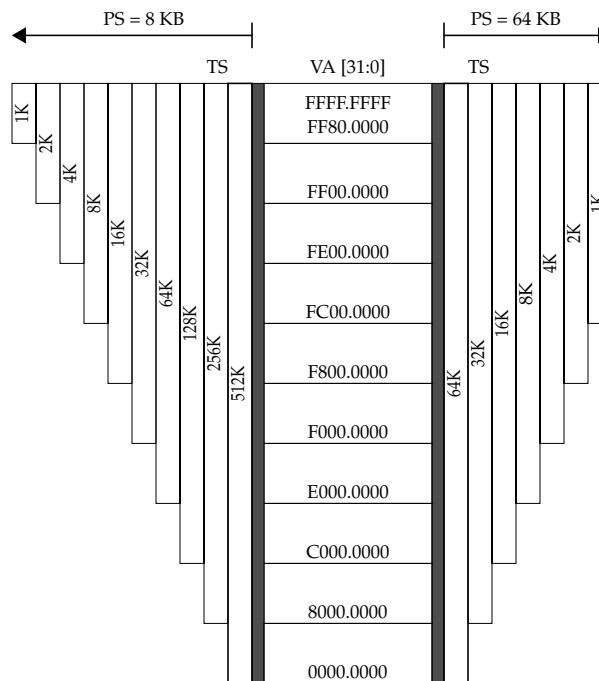
Figure 1-3 Translation Size Virtual Address Configurations

The size of the TSB table determines the range on the virtual addresses which are valid. Addresses not in the valid range cause a translation out-of-range error (TRN_OOR). TSB sizes and page sizes which are not diagrammed in this figure are not valid and produce undefined results.

Mode	TE	BE	Addr[63:42]	Addr[31:0]	Result
32-bit	0	X	N/A	N/A	MMU TRN_ERR
32-bit	1	X	N/A	Figure 1-3	Figure 1-3
64-bit	X	0	X	N/A	MMU BYP_ERR

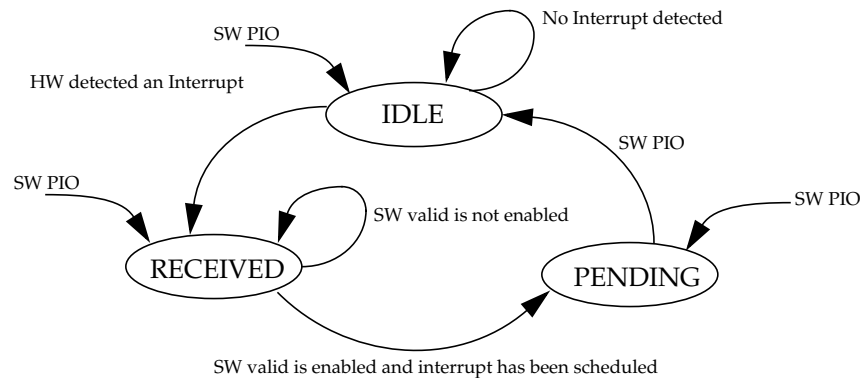
Fire uses a subset of interrupt state machine in Schizo and Tomatillo. An interrupt is always a "level" sensitive interrupt. An interrupt can be in one of three states: IDLE, RECEIVED, or PENDING. IDLE represents the state where no interrupts are reported. RECEIVED indicates that an interrupt has been detected and should be delivered to the processor if/when the valid bit is set in its mapping register. PENDING is the state when the interrupt has been queued to be or has been sent to the processor. Any subsequent detection of the same interrupt is ignored until software resets the state machine back to IDLE. The state register for each level sensitive interrupt can be set to any desired state by software via the Interrupt Clear Registers.

Note – Software should ensure that the source of a level sensitive interrupt is cleared before clearing the interrupt state register via the Interrupt Clear Register, otherwise Fire will continue to reissue the interrupt each time the state register is set to IDLE.

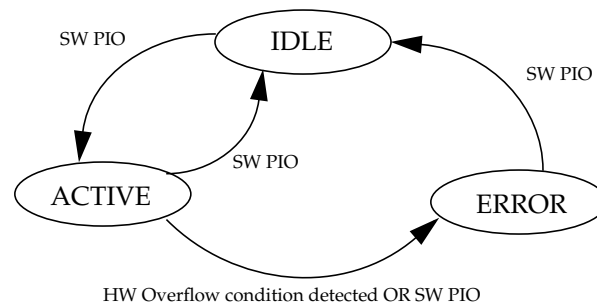
For Fire, all event queues live in a contiguous memory region, where the first event queue must be aligned on a programmable 512 Kbyte boundary. Each event queue has a fixed size of 128 entries (one 8 Kbyte page) but is considered full at 127 entries.

Each event queue has the following state included; enable/disable event queue, head index, tail index, overflow error occurred, and the event queue state (IDLE, ACTIVE, ERROR). Software can induce any of state transitions with the exception of IDLE to ERROR.

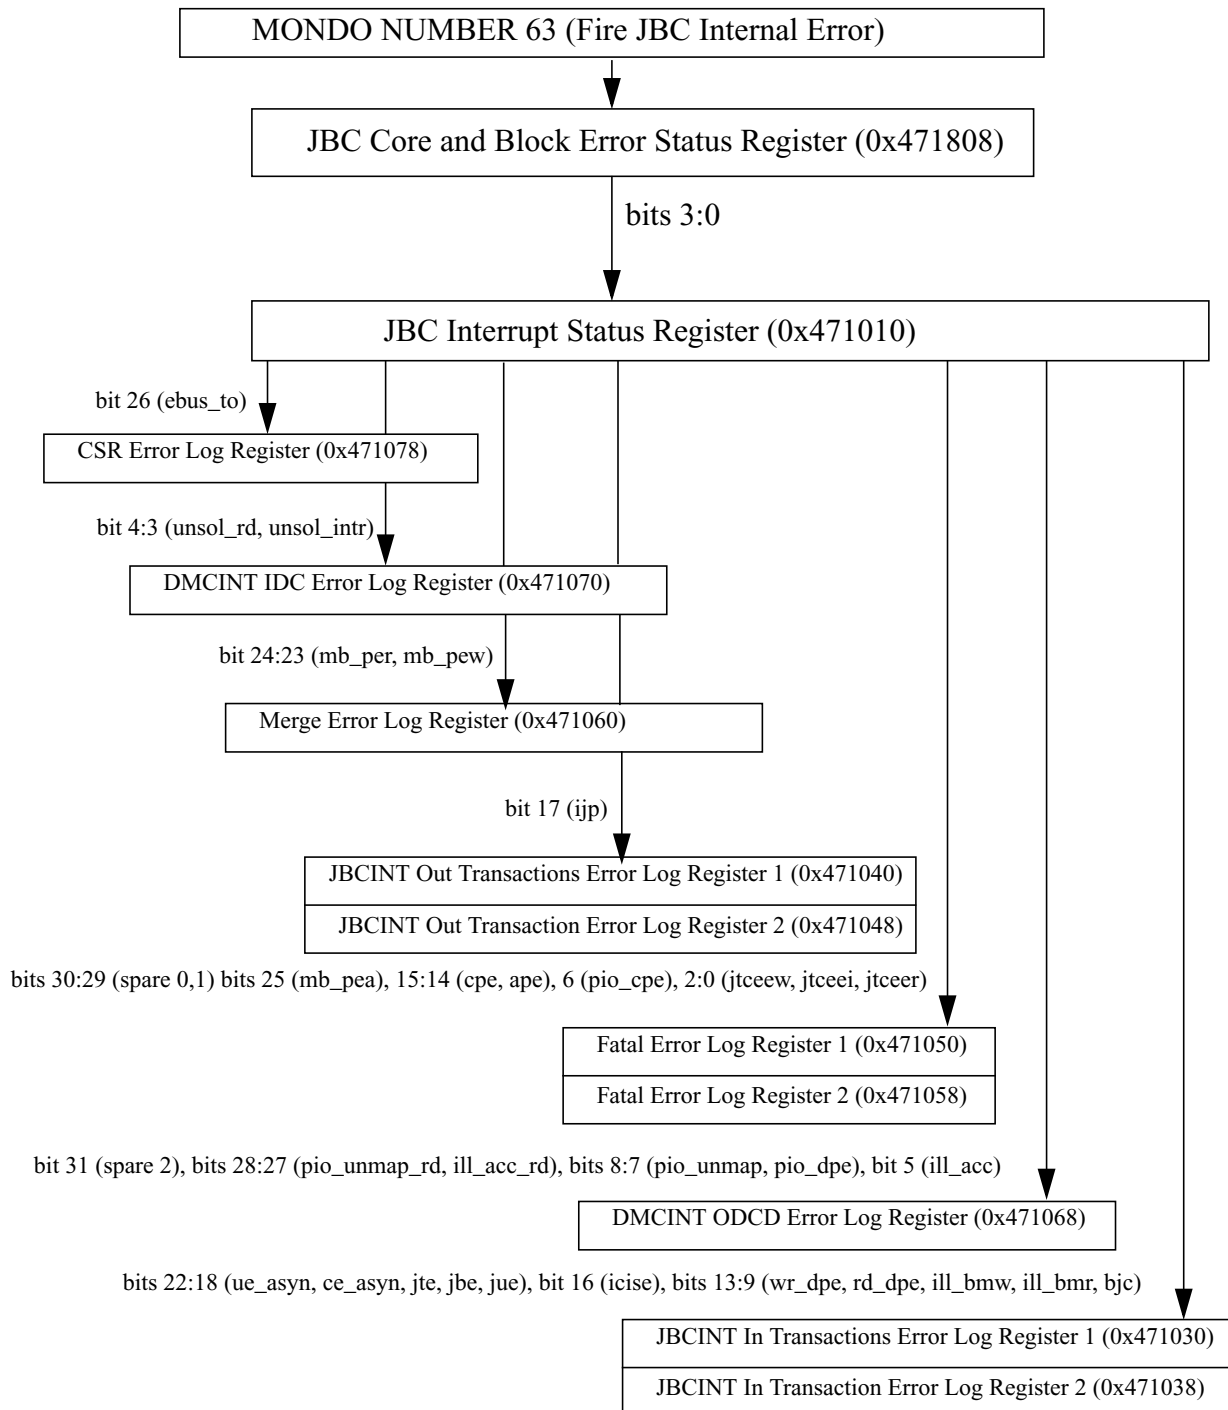
Figure 1-4 Mondo 63 Fire JBC Internal Error Processing Diagram

To clear any of the errors detected in the JBC Core, the JBC Error Status Clear Register (0x471018) should be used.

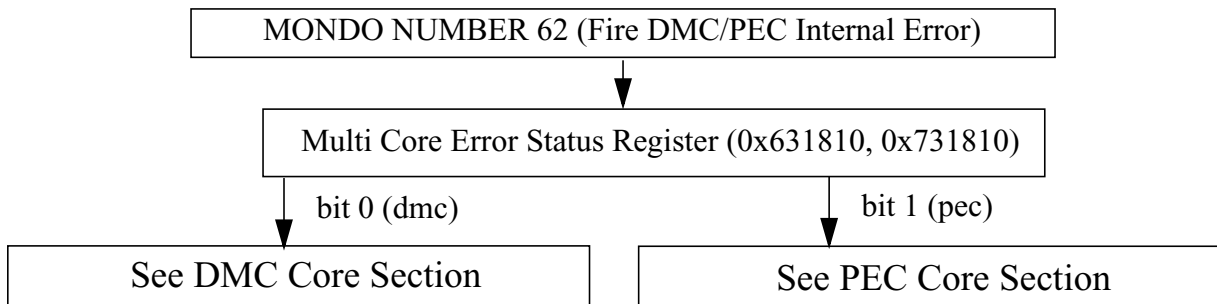
Figure 1-5 Mondo 62 Fire DMC & PEC Internal Error or Event Processing Diagram

When software receives a Mondo from INO 62, this signifies that an internal Fire error or event was detected in the DMC or PEC Core. Below in the following figures and descriptions are shown the details and the necessary registers that should be read when a mondo 62 is received.

The first register to be read should be the Multi Core Error Status Register (0x631810, 0x731810) This register describes which of one or more than one of the 2 possible cores the Mondo 62 came from. If bit 0 is set in this register the Mondo was caused by the DMC core. If bit 1 is set in this register the Mondo was caused by the PEC Core

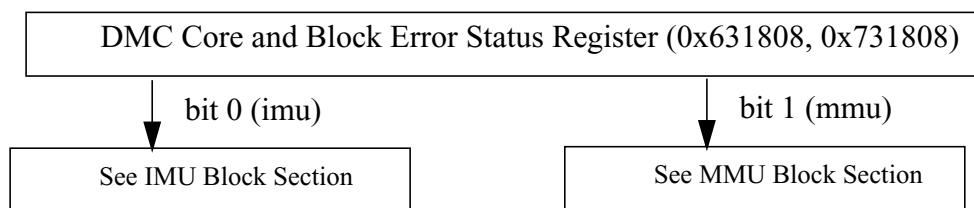
Figure 1-6 DMC Core Error Processing Diagram

If Mondo 62 was caused by the DMC Core the next register that should be read is the DMC Core and Block Error Status Register (0x631808, 0x731808). This register describes which of one or more than one of the 2 possible block(s) in the DMC Core has an error which needs to be processed. If bit 0 is set in this register the Mondo was caused by the IMU block. If bit 1 is set in this register the Mondo was caused by the MMU block

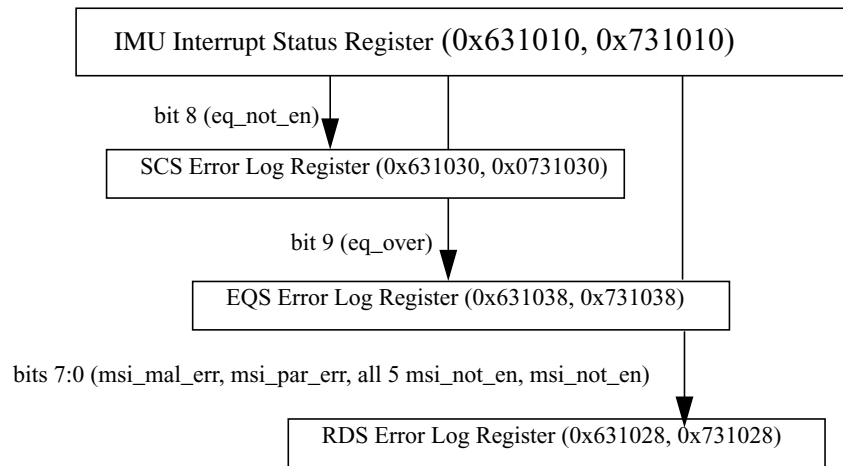
Figure 1-7 IMU Block Error Processing Diagram

If Mondo 62 was caused by the IMU Block the next register that should be read is IMU Interrupt Status Register (0x631010, 0x731010). This register shows all of the possible IMU Errors which could have generated a mondo 62. From these bits further information about the particular error can be obtained by further reading the proper Error logging register. Please see the diagram for details on these registers.

To clear any of the errors detected in the IMU Block, the IMU Error Status Clear Register (0x631018, 0x731018) should be used.

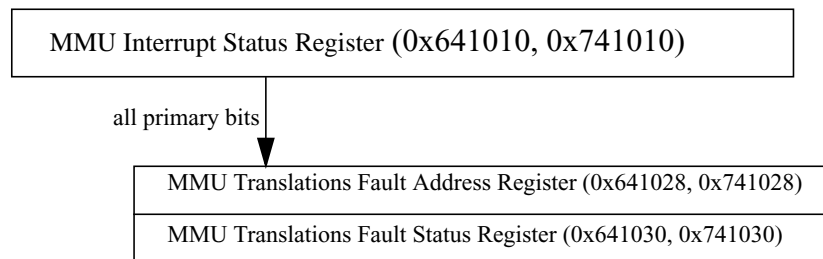
Figure 1-8 MMU Block Error Processing Diagram

If Mondo 62 was caused by the MMU Block the next register that should be read is MMU Interrupt Status Register (0x641010, 0x741010). This register shows all of the possible MMU Errors which could have generated a mondo 62. From these bits further information about the particular error can be obtained by further reading the proper Error logging register. Please see the diagram for details on these registers.

To clear any of the errors detected in the MMU Block, the IMU Error Status Clear Register (0x641018, 0x741018) should be used.

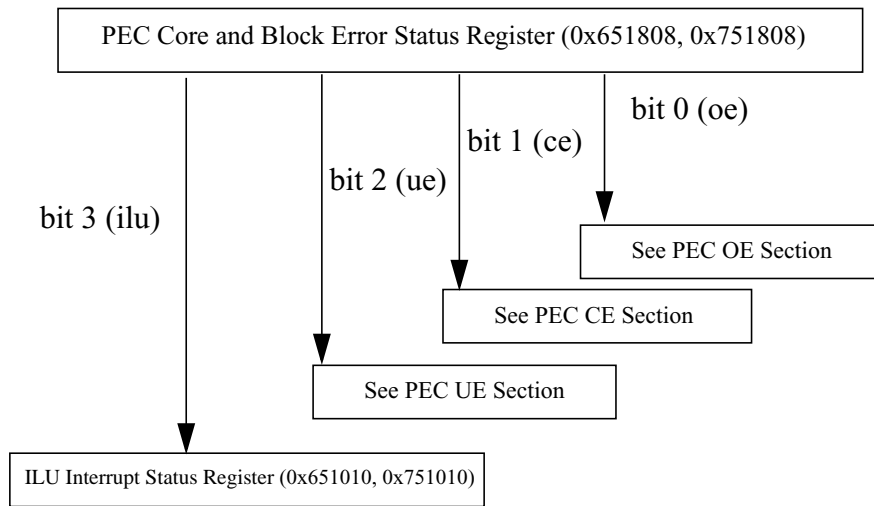
Figure 1-9 PEC Core Error Processing Diagram

If Mondo 62 was caused by the PEC Core the next register that should be read is the PEC Core and Block Error Status Register (0x651808, 0x751808). This register describes which one or more than one of the 4 possible block(s) in the PEC Core has an error which needs to be processed. If bit 0 is set in this register the Mondo was caused by the a PEC OE register. If bit 1 is set in this register the Mondo was caused by the PEC CE Register. If bit 2 was set in this register the Mondo was caused by the PEC UE Register. If bit 3 was set in this register the Mondo was caused by the ILU block.

To clear any of the errors detected in the ILU Block, the ILU Error Status Clear Register (0x651018, 0x751018) should be used.

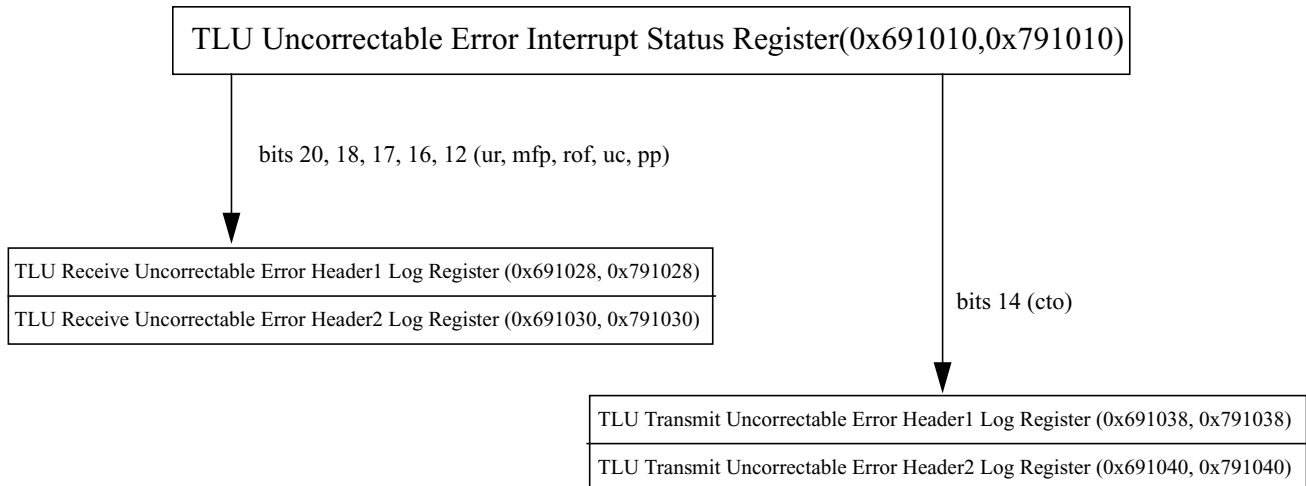
Figure 1-10 PEC UE Error Processing Diagram

If Mondo 62 was caused by a PEC UE error or event the next register that should be read is TLU Uncorrectable Error Interrupt Status Register(0x691010,0x791010). This register shows all of the possible TLU UE Errors and events which could have generated a mondo 62. From these bits further information about the particular error can be obtained by further reading the proper Error logging register. Please see the diagram for details on these registers. Also note that bits 13 and bits 15 of this register DO NOT store any additional data with the errors and are not show in this diagram.

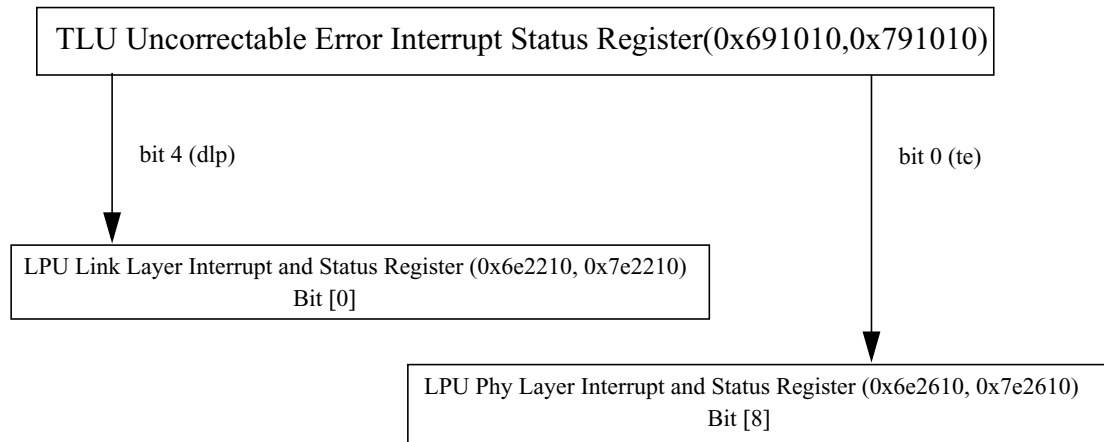
Figure 1-11 PEC UE Duplicate Error Diagram

Since this register, can store errors that are detected by the LPU as well as the TLU some of this information may be duplicated in the LPU in a different register. In the following diagram any bits which could store duplicate information are describe along with the register and the bit which would be duplicate.

To clear any of the errors detected in the in TLU UE register, the TLU Uncorrectable Error Status Clear Register (0x691018, 0x791018) should be used. To clear the duplicate registers in the LPU the LPU Link Layer Interrupt and Status Register (0x6e2210, 0x7e2210) should be used for the dlp duplicate error (bit 0 of that register) and the LPU Phy Layer Interrupt and Status Register (0x6e2610, 0x7e2610) should be used for the duplicate te error (bit 8 of that register).

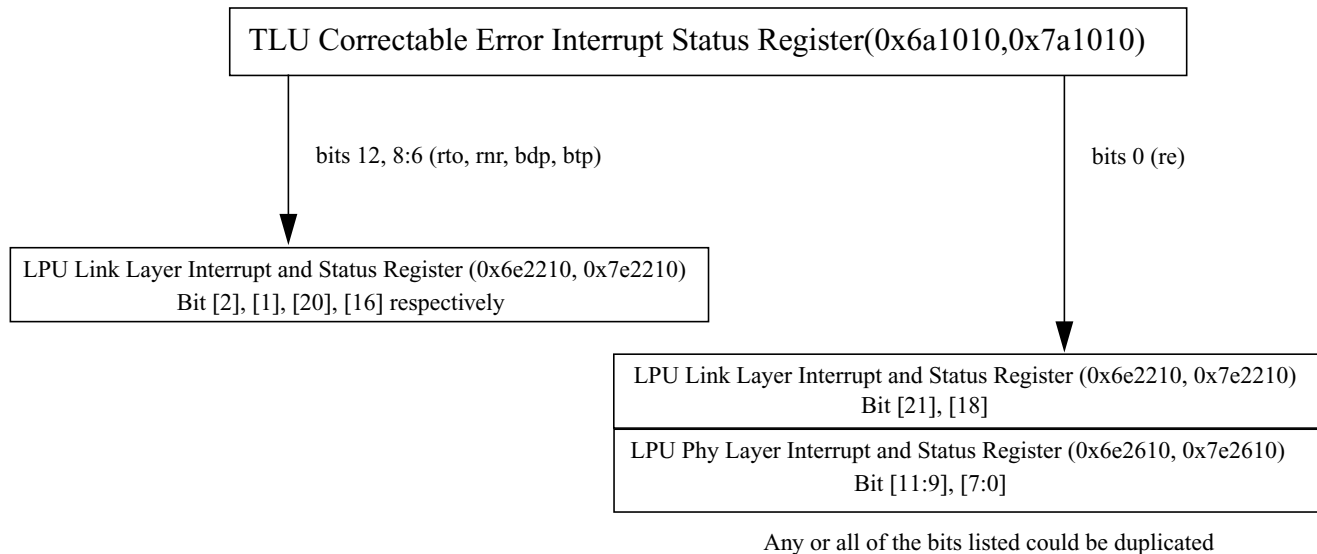
Figure 1-12 PEC CE Duplicate Error Diagram

Since this register, can store errors that are detected by the LPU as well as the TLU some of this information may be duplicated in the LPU in a different register. In the following diagram any bits which could store duplicate information are describe along with the register an the bit which would be duplicate.

To clear any of the errors detected in the in TLU UE register, the TLU Correctable Error Status Clear Register (0x6a1018, 0x7a1018) should be used. To clear the duplicate registers in the LPU the LPU Link Layer Interrupt and Status Register (0x6e2210, 0x7e2210) and the LPU Phy Layer Interrupt and Status Register (0x6e2610, 0x7e2610) should be used for the appropriate duplicate bits.

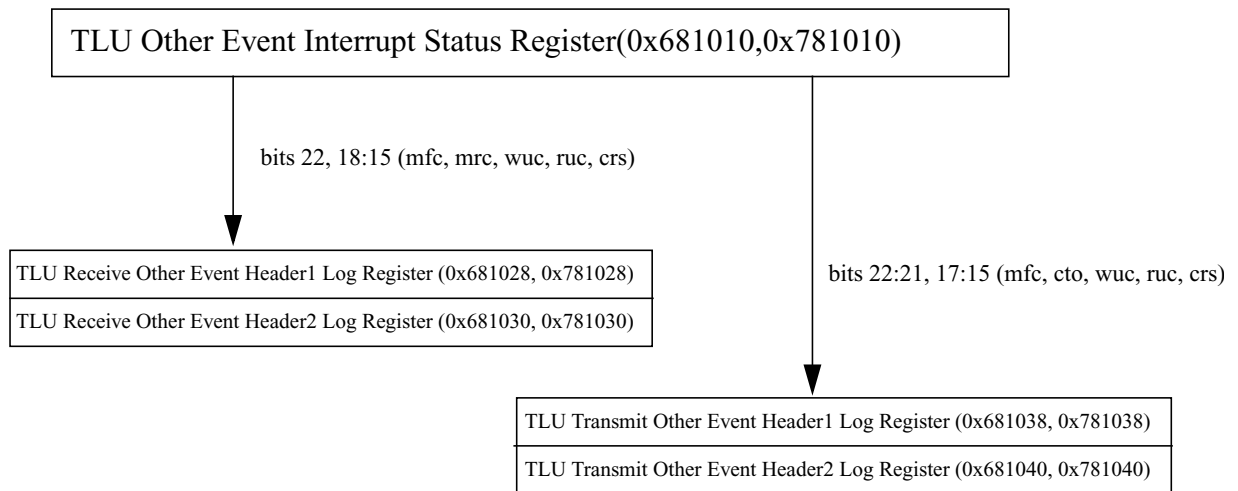
Figure 1-13 PEC OE Error Processing Diagram

mondo 62. From these bits further information about the particular error can be obtained by further reading the proper Error logging register. Please see the diagram for details on these registers.

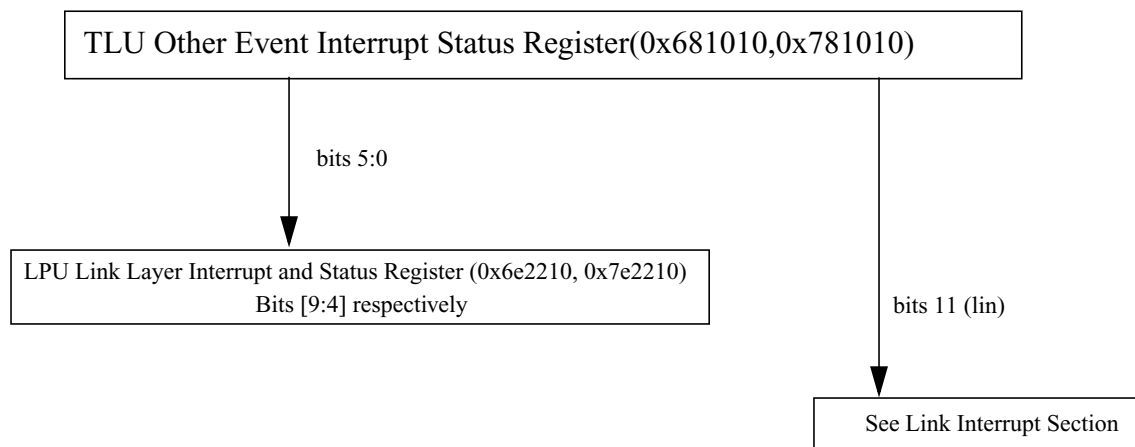
Figure 1-14 PEC OE Duplicate Error Diagram

Since this register, can store errors that are detected by the LPU as well as the TLU some of this information may be duplicated in the LPU in a different register. In the following diagram any bits which could store duplicate information are describe along with the register an the bit which would be duplicate.

To clear any of the errors detected in the in TLU OE register, the TLU Other Event Status Clear Register (0x681018, 0x781018) should be used. To clear the duplicate registers in the LPU the LPU Link Layer Interrupt and Status Register (0x6e2210, 0x7e2210) should be used.

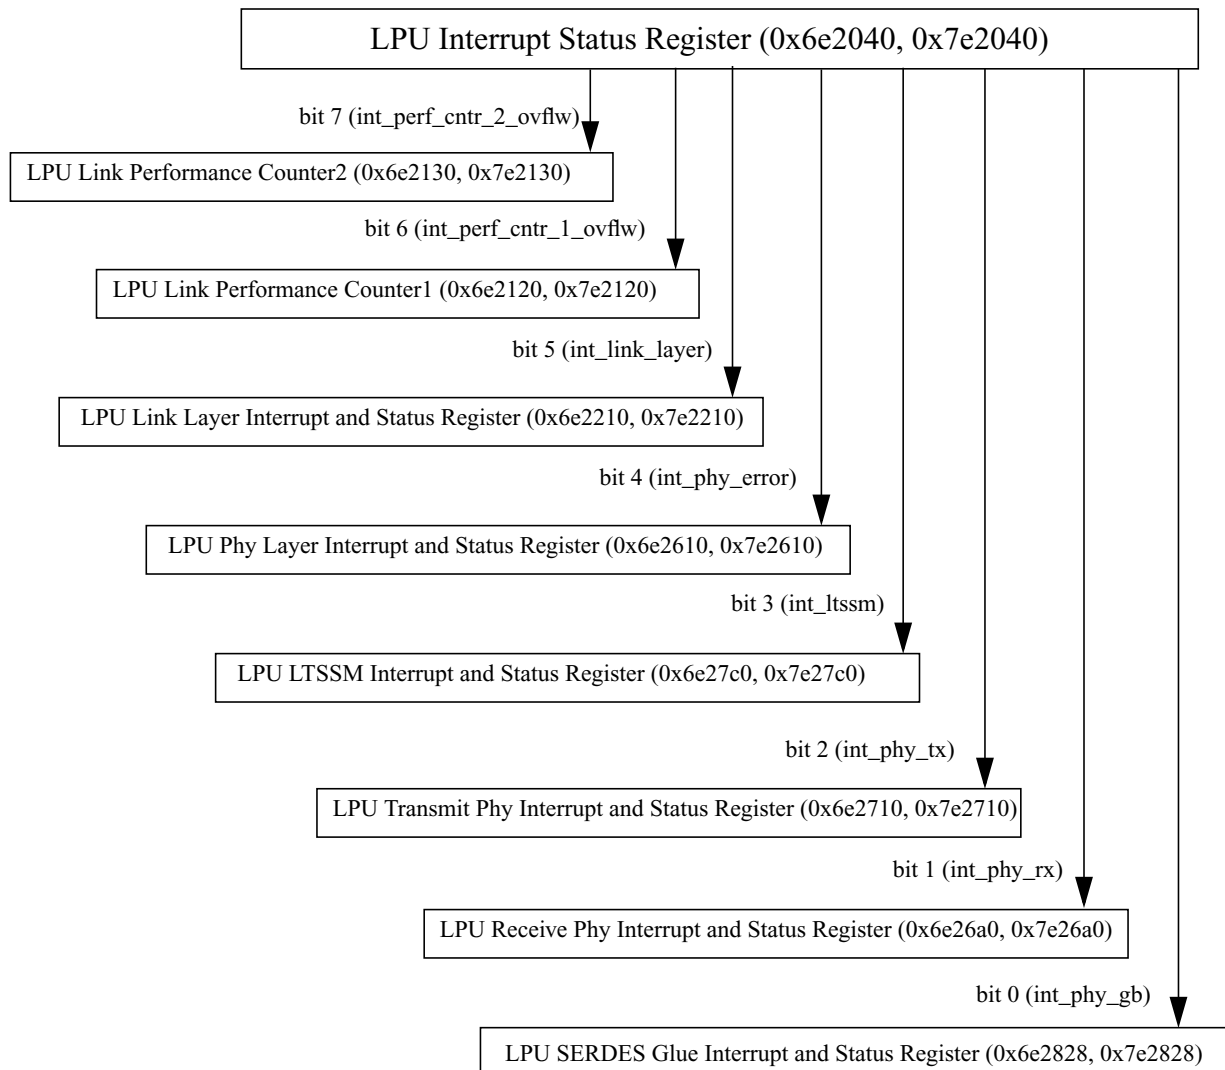
Figure 1-15 Link Interrupt Processing Diagram

If Mondo 62 was caused by an Link Interrupt the next register that should be read is LPU Interrupt Status Register (0x6e2040, 0x7e2040). This register describes which of the one or more than one of the 8 possible block(s) in the LPU has an error or event which needs to be processed. From these bits further detail on the specific cause of the error can be found by further reading the proper interrupt and status register. Please see the diagram for details on these registers.

To clear any of the errors detected by the link interrupt bit, the respective interrupt and status register shown above should be used.
